DPRI-VMGD joint survey
for Cyclone Pam damages

May 19, 2015

Disaster Prevention Research Institute, Kyoto University

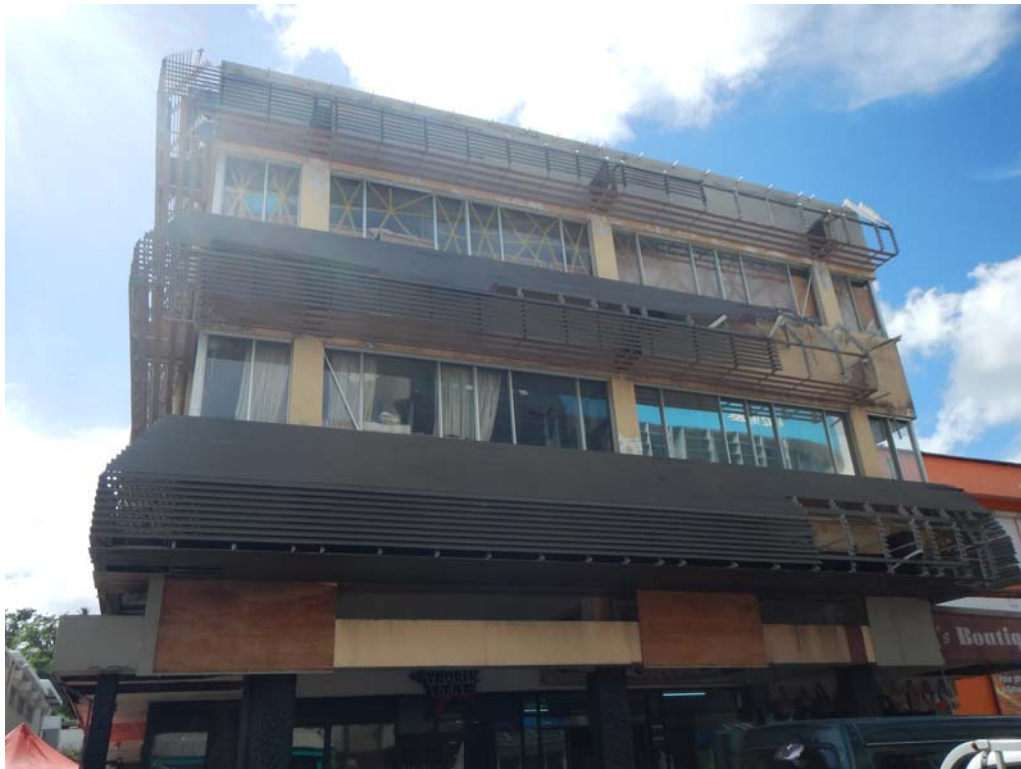
Most of the damages to RC structures seem limited to non-structural components such as envelopes and interiors. The building in Figure 6 is a commercial building located in Port Villa, Efate Island. As seen, the damages are limited to its envelop, part of which is believed damaged due to lack of shutters. Significant damages are also observed to interior such as ceilings and partitions. It should be noted that many commercial buildings in Port Vila are equipped with shutters, many of which seem undamaged.

Figure 6. Damages to envelop of commercial building in Efate Island.

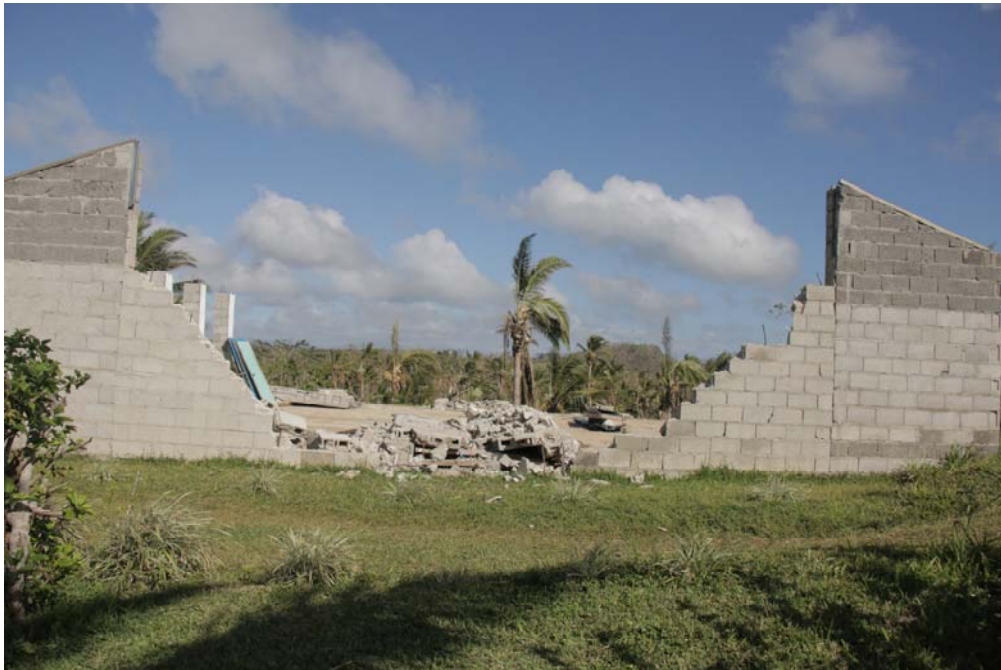
Collapses of concrete block structures were also observed. The totally collapsed building seen in Figure 7 is located in Tanna Island. The mortar joints seem relatively weak, and amount of rebar few and it lacks stiffness. It had been used as church and in the event of the Cyclone Pam several people in the village first evacuated to the church.

Figure 7. Totally collapsed church in Green Hill in Tanna Island.

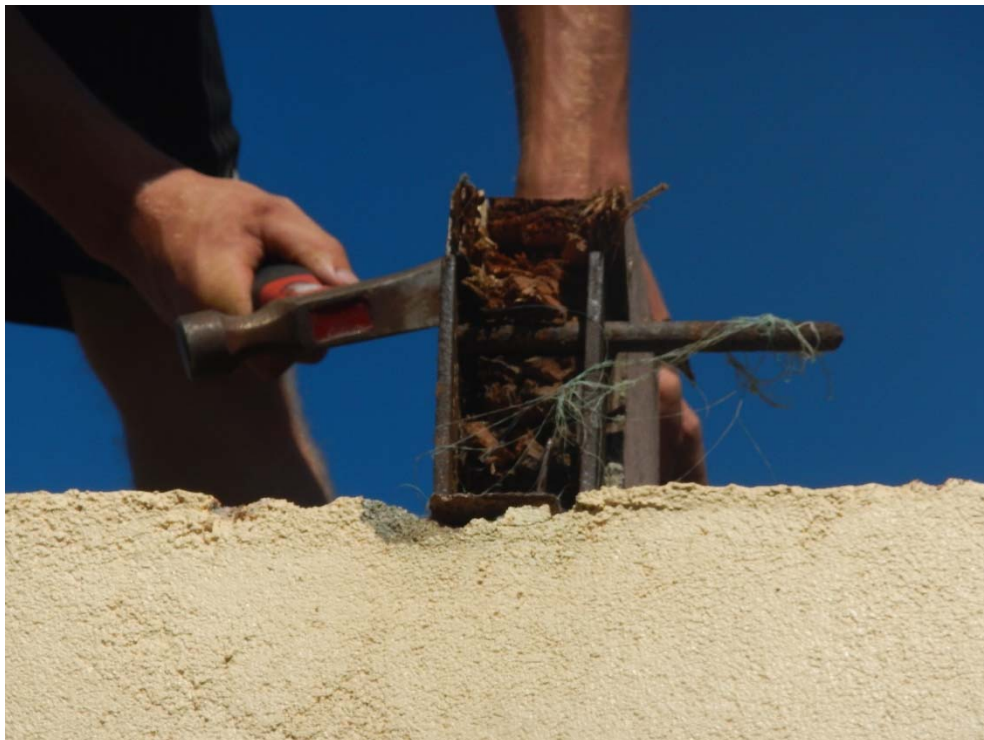
Significant deterioration of components were identified in many modern buildings that were damaged, see Figure 8. Steel connections are often rusted and un-treated timber products were deteriorated in those buildings.

Figure 8. Deteriorated component of damaged school building.

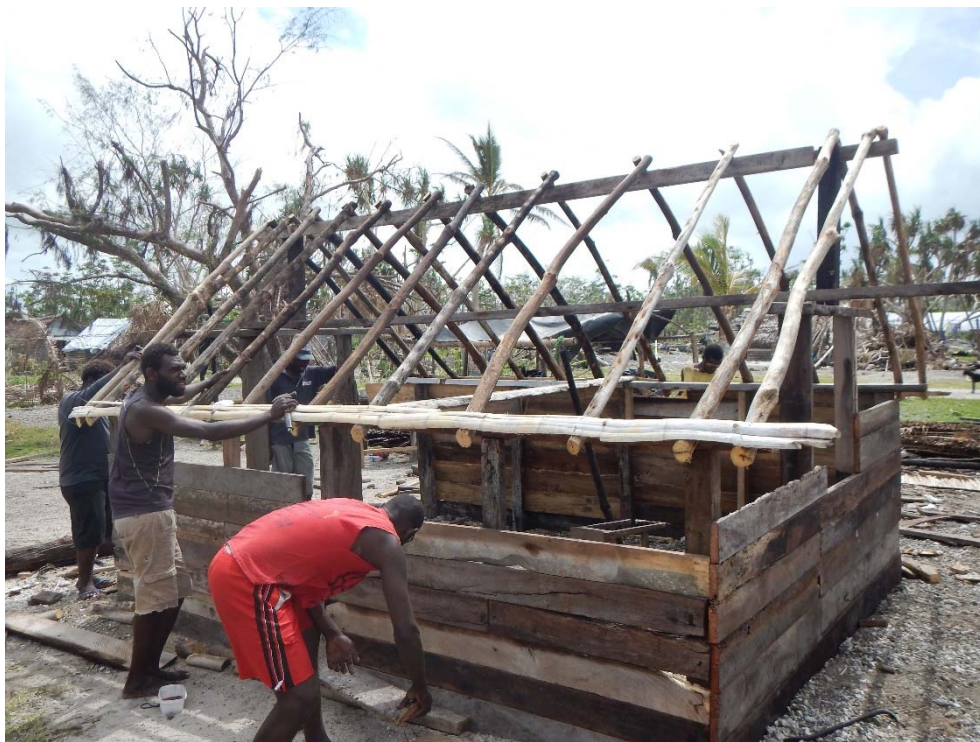
Most of traditional houses had been destroyed or damaged, according to the testimonies of local people; however, many of them were already reconstructed when the survey was conducted. Typical houses are made of woods for columns, beams and roof structures; roofs are covered with dried leaves, grasses, wild canes and sometimes with support of bamboos. Simple industrial construction materials such as nails and screws and construction instruments such as chain saw are available in some cases. Figure 9 and Figure 10 show traditional houses under reconstruction in two villages in Efate Island.

Figure 9. Traditional house under reconstruction at Eton, Efate Island.

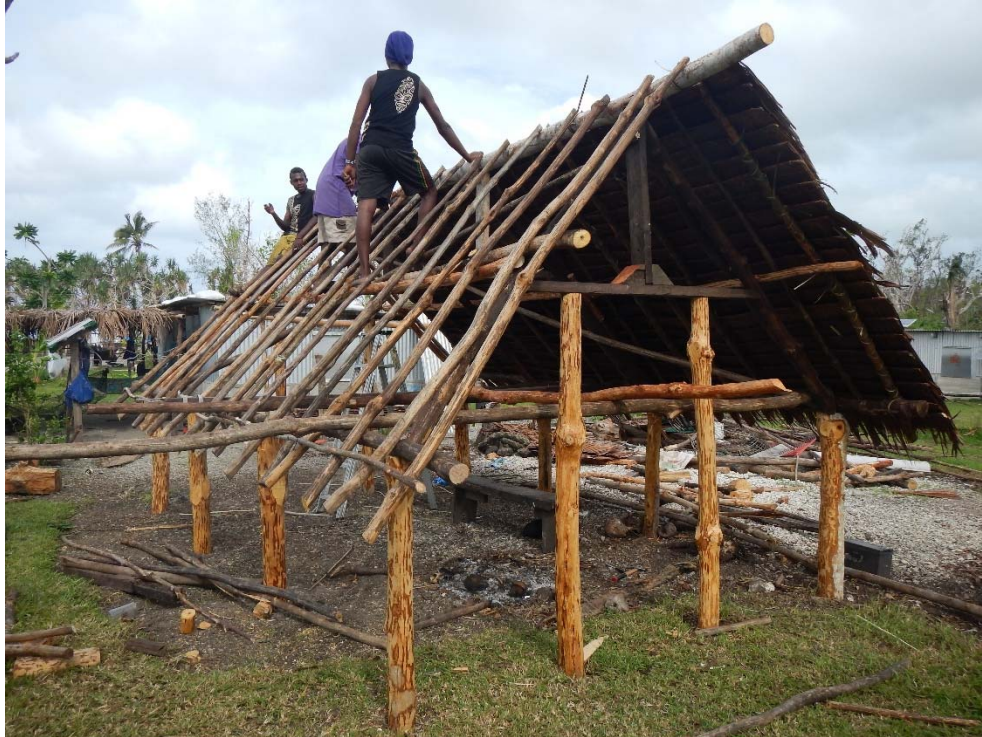
The house in Figure 10 has the dimension of 3140 mm in width, 2720 mm in height and 5270 mm in depth. It has narrow eaves. The columns are made of Mango tree. The diameter of the columns is around 120 mm and the columns are casted into the soil by around 500 mm. The rafters are made of Oak tree. The diameter of the rafters is around 60 mm. The ridgepole is made of a kind of nut tree. These trees were cut in the forest nearby, brought to the site and cut with a chain saw. For the connections nails are used.

Figure 10. Traditional house under reconstruction at Epao, Efate Island.

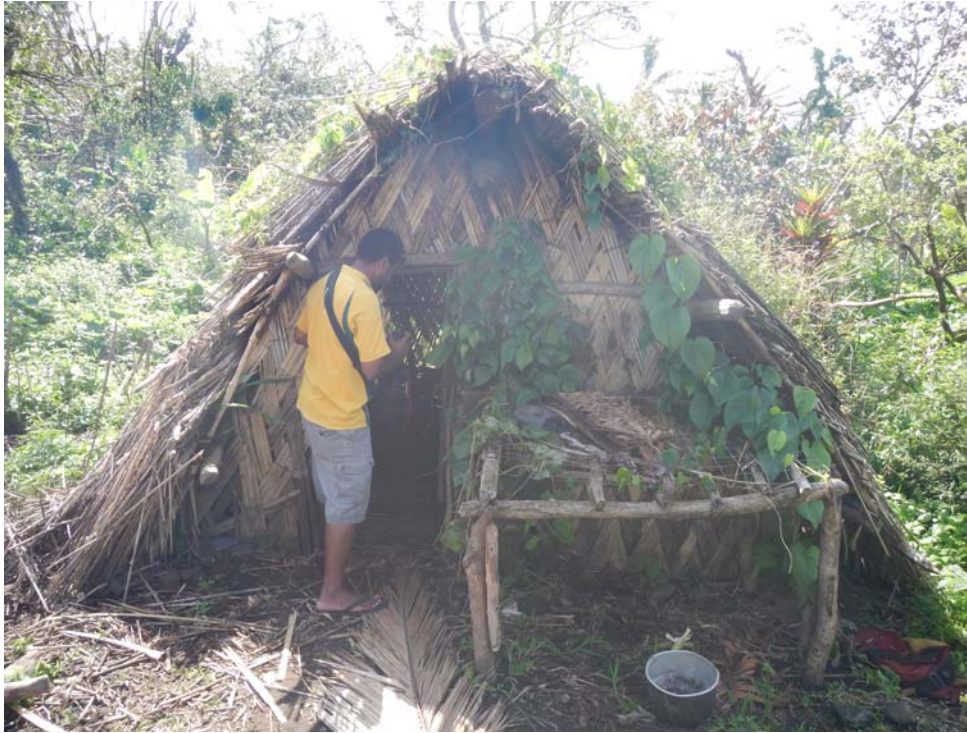
There are several testimonies that people in villages in Tanna Island evacuated to traditional cyclone shelters and those shelters did not fail during the cyclone. Figure 11 shows an example of the traditional cyclone shelter in Tanna Island and Figure 12 shows a traditional cyclone shelter that are being built after Cyclone Pam. Although the dimensions and details are diverse, there is a common characteristics in the traditional cyclone shelter. That is, the roof is extended to the ground. The shape seems empirically optimized to best resist against strong wind.

Figure 11. Traditional cyclone shelter at Yakel in Tanna Island.

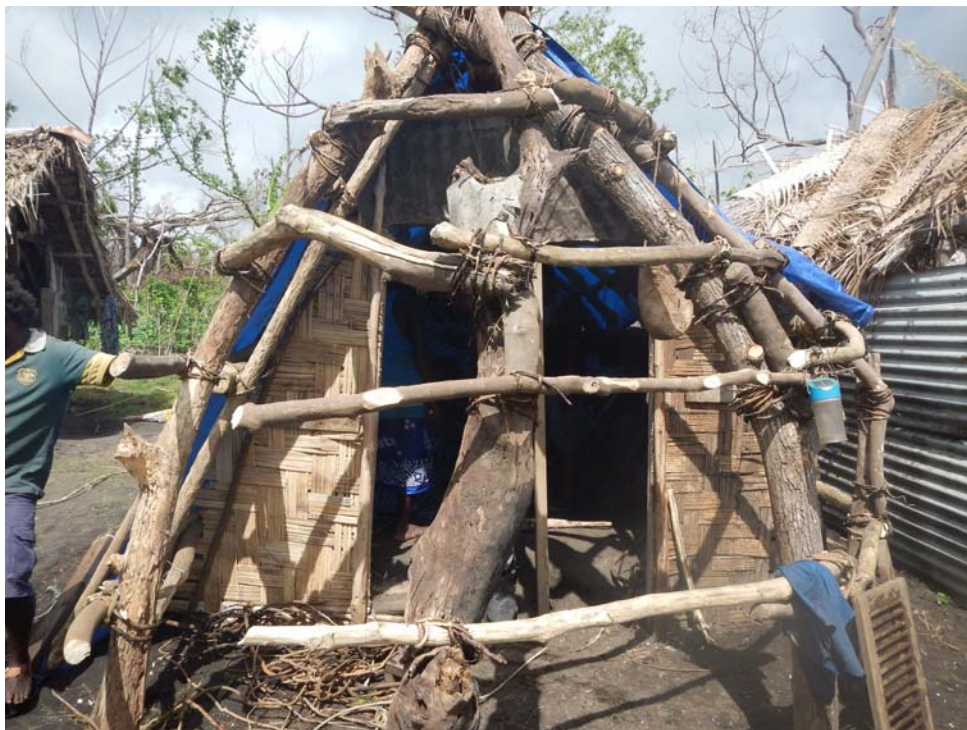
Figure 12. Newly constructed traditional cyclone shelter at Loutapunga in Tanna Island.

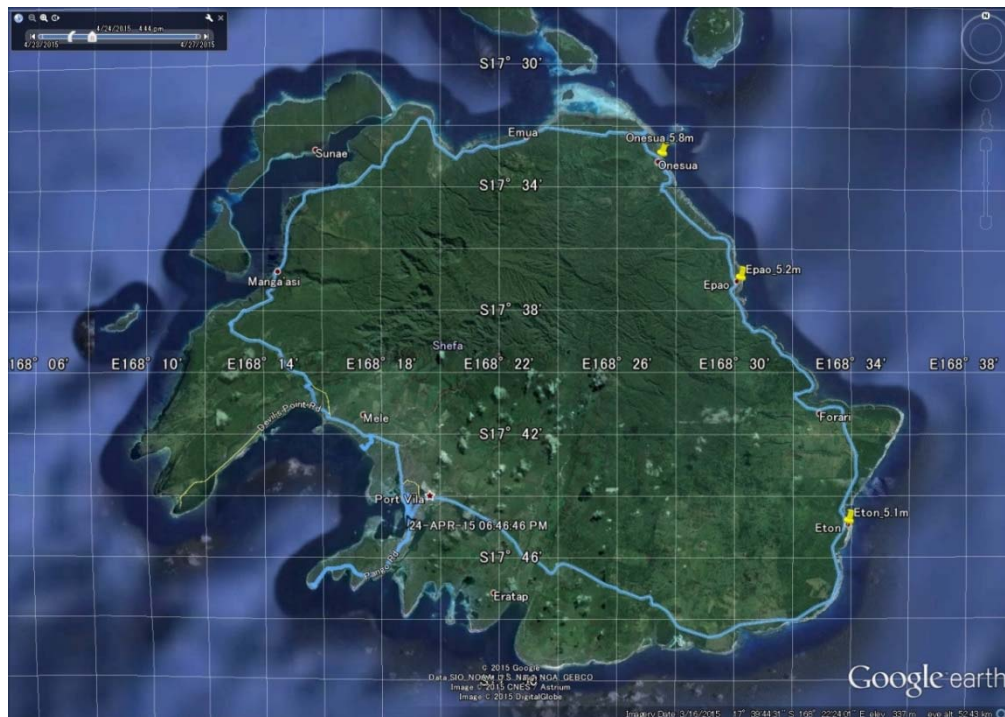
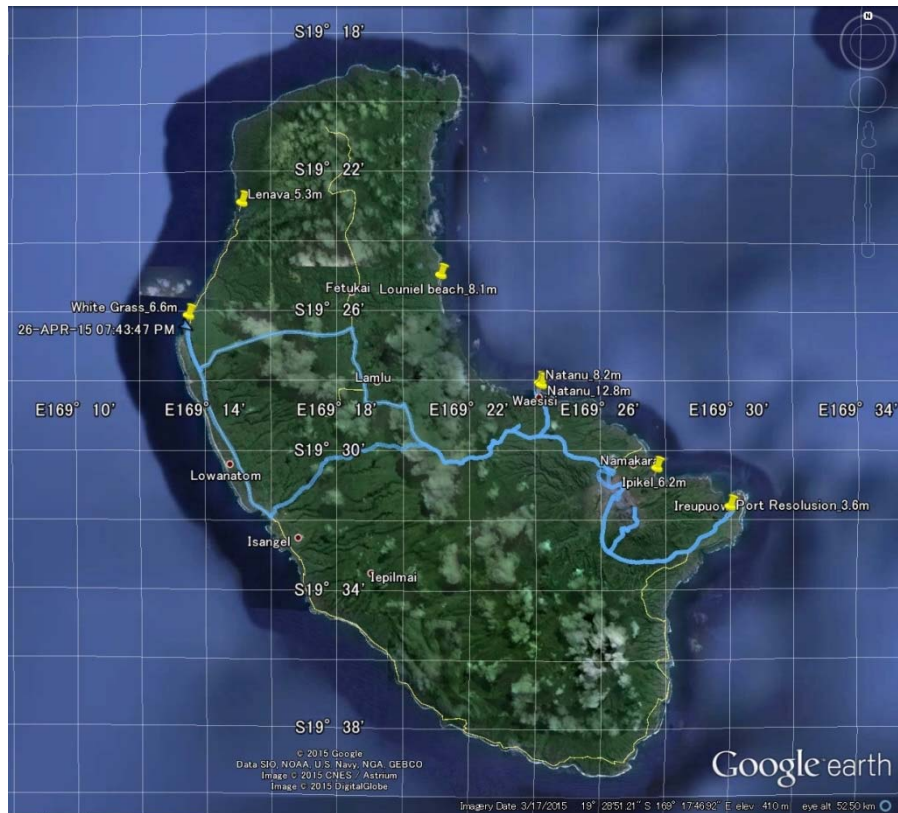
Figure 13. Measured run-up and inundation height from MWL (unit: m).

Wave run-up and inundation heights were measured according to interview to local residents by an auto-level and a laser range finder. The survey follows protocol of the post-tsunami survey field guide by IOC. Figure 13 displays the survey results in Efate Island and Tanna Island. In Efate Island, coastal inundation was mainly observed along the east coasts, e.g. Eton, Epao, and Onesua, and the maximum run-up heights were about 5 m from the mean sea level (MSL) excluding tidal effects. In Tanna Island, inundation heights were larger than that of Efate due to larger offshore wave height shown in Figure 4. Along northwest coast of Tanna where the distance is close to the cyclone eye, 5–6 m run-up above MSL was observed at Lanava and White Grass. On the other hand, in the northeast coast of the island, large inundation which is 8 m was observed where the fetch was the longest without shading effects of islands. Severe beach cliff erosion was observed at Louniel beach, which height was about 6 m as shown in Figure 14. Several ships made of FRP were flown and run-up at Natanu, Waisisi. Inundation heights gradually decrease to south in the east coast due to shading of peninsula. At Ipikel facing the Sulfur bay, inundation height was about 6 m, and at the Port Resolution run-up height becomes less than 4 m. SPC report summarized that the satellite image of the North East of Erromango shows major coastal erosion and inundation. We observed similar phenomena by extreme waves in Tanna Island visually.

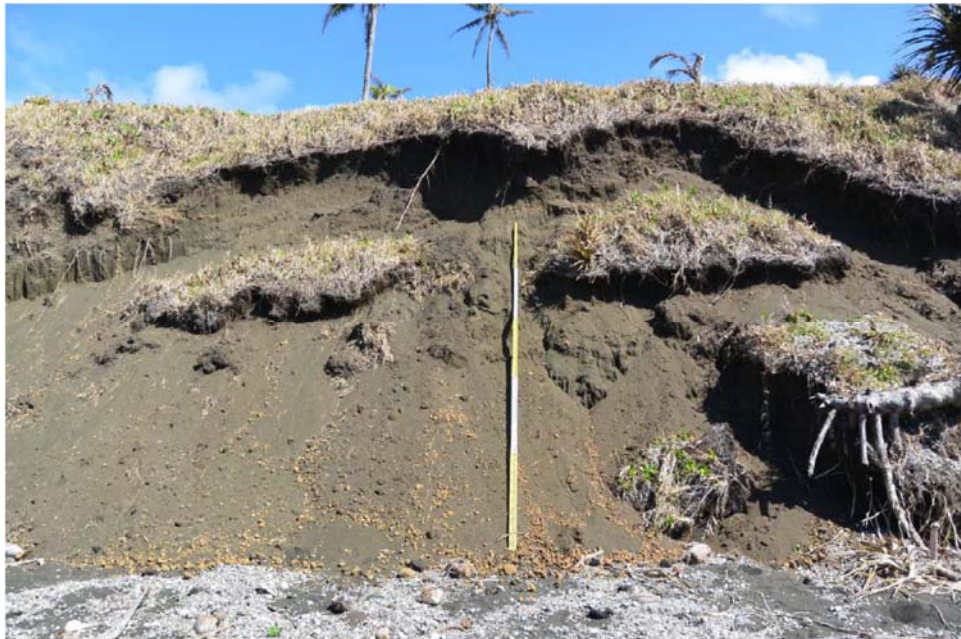
Figure 14. Sevier coastal cliff erosion at Louniel beach in Tanna Island.

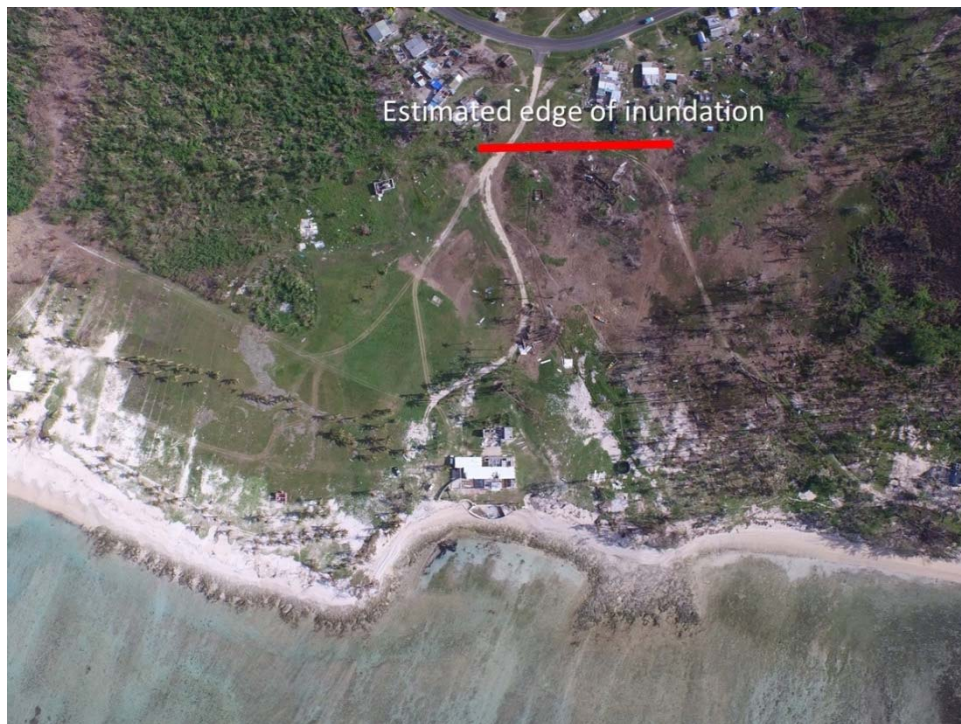
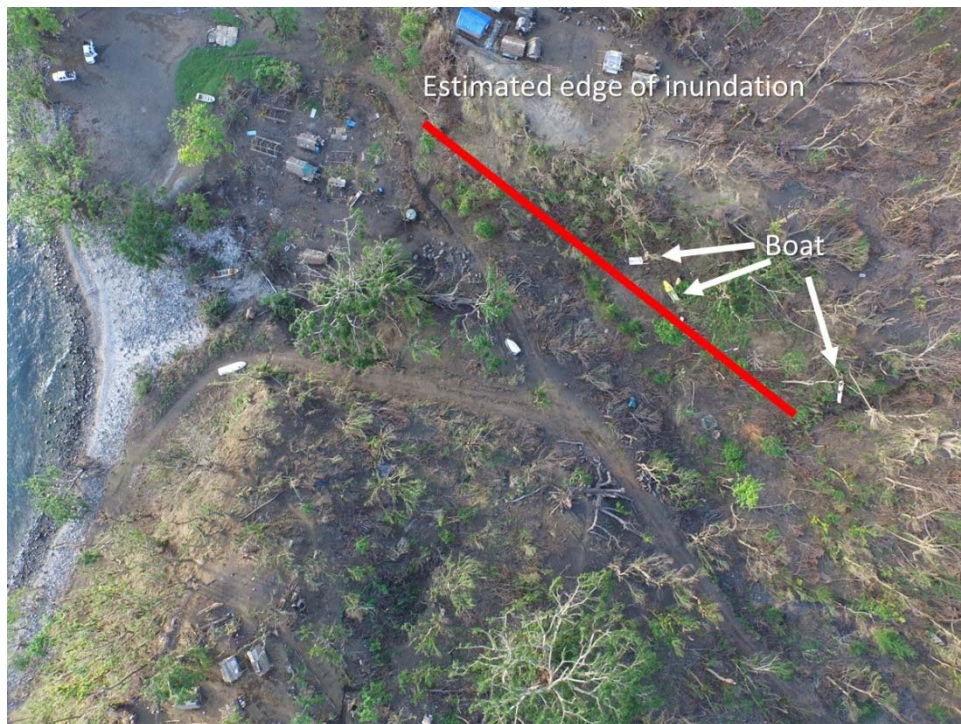
Figure 15. Snapshot of observed coastal wave inundation by drone.

The long distance inundations were observed several locations. One example is Baofatu beach (Takara hot spring) at the northeast coast of Efate island. Figure 15 (a) shows aerial snapshot of observed coastal inundation by a drone. There are many boulders of coral rocks from the reef and concrete blocks from coastal walls until 100 m along the coast. The maximum distance of inundation is 300 m and it was remained more than 2 days according to witness evidence by local residence. The highest run-up of coastal flooding was observed at Waisisi village in southeast coast of Tanna Island (Figure 15 (c)). The maximum run-up height was about 12 m and propagated up to 300 m from the coast line. The severe coastal inundations are measured east coast of Tanna island that feature is matched with numerical hindcast shown in Figure 5.
